# Inspection Report

**Company** Heat Seeker - Thermal Imaging  
**Address** 119 Kutz Cres, Saskatoon, Sk S7N 4S5  
**Thermographer** Clifford Gerow

**Customer** Paul Jones  
**Site Address** 218 Fun Street Saskatoon, Sk  
**Contact Person** Paul Jones

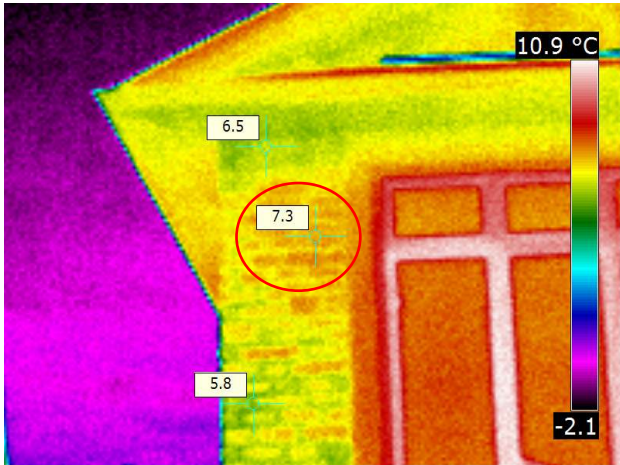
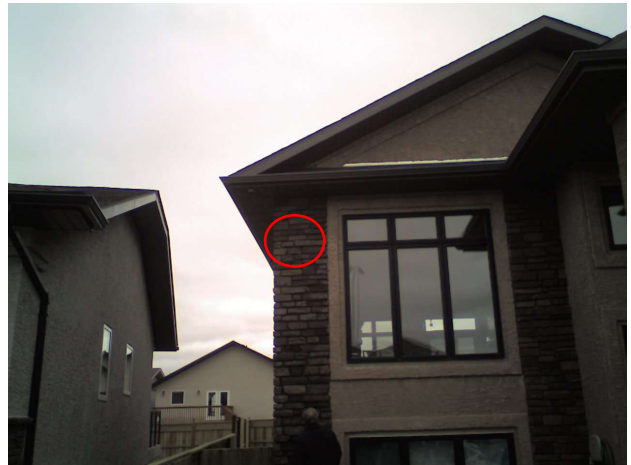
Description
moisture intrusion behind the brick work

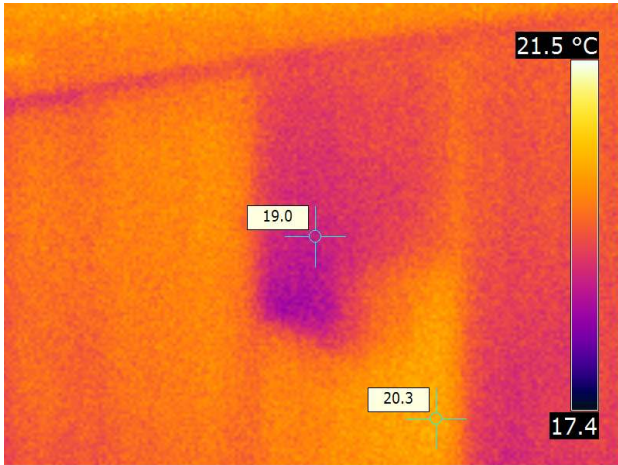
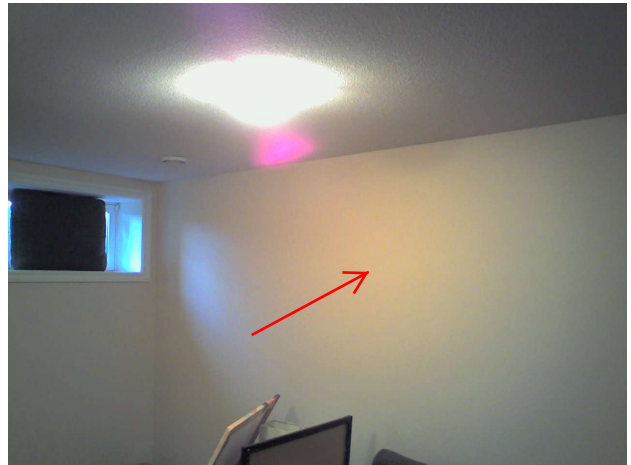
Description
missing insulation behind the finished wall in the basement

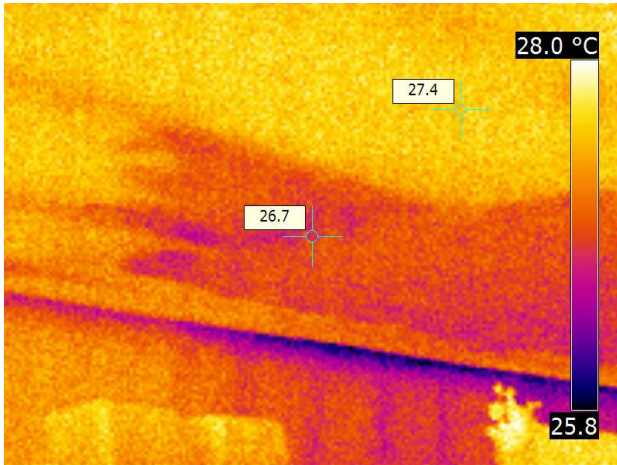
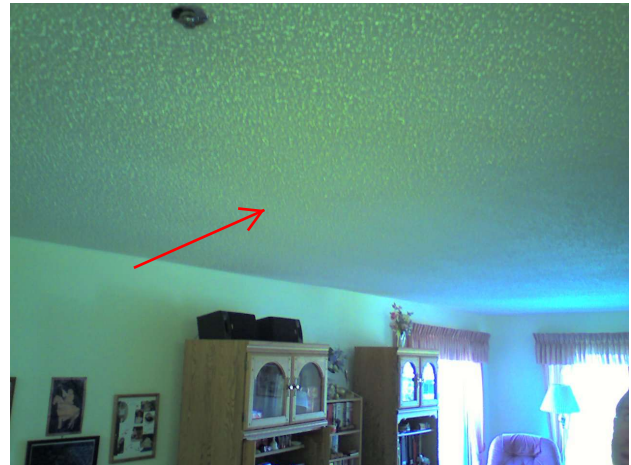
Description
Moisture intrusion(dark area) that starts in middle of the kitchen area and goes to the east wall where the window is leaking

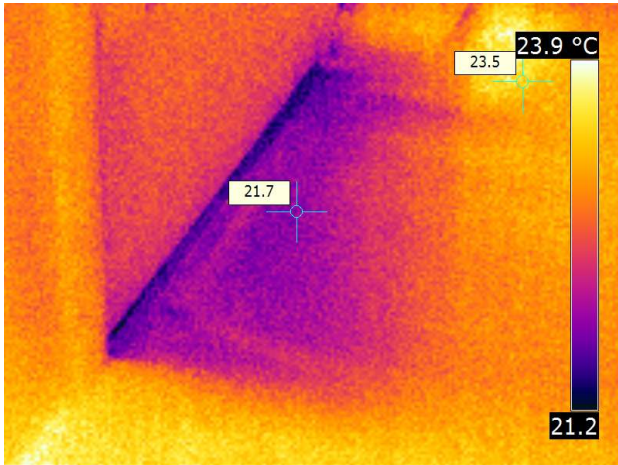
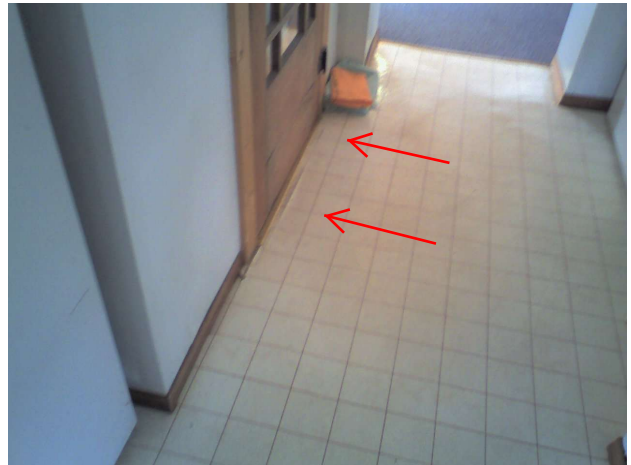
Description
darker area indicates there is moisture under the lino that appears to be coming from the bathroom area

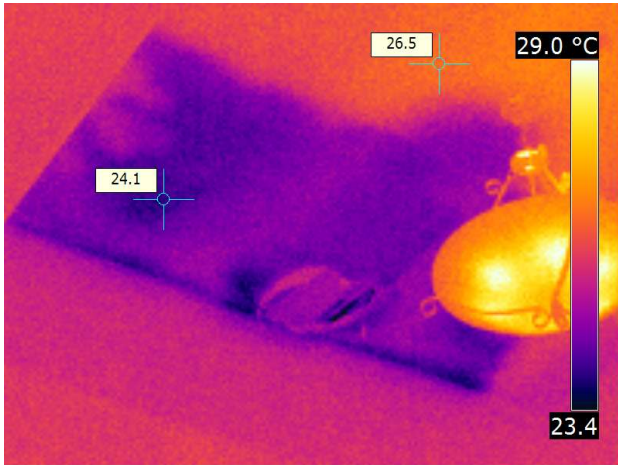
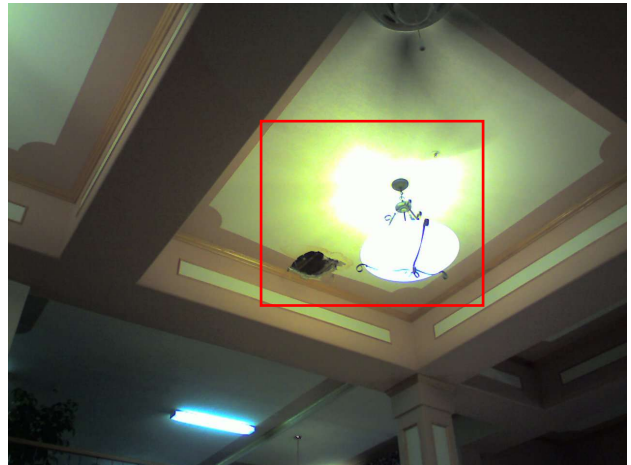
Description
Dark area shows how invovled the moisture is in the ceiling, that will need to be replaced to avoid mold growth

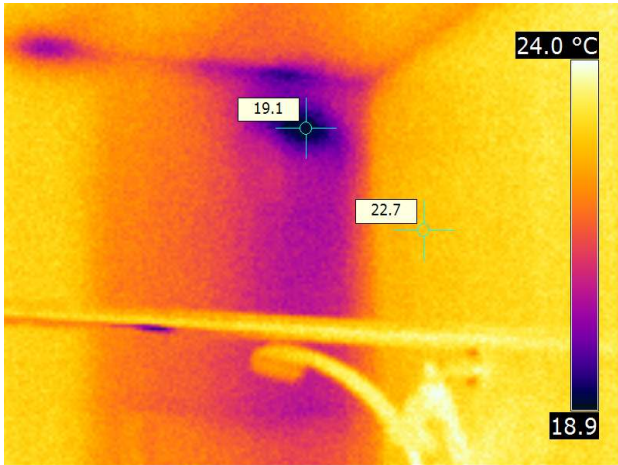
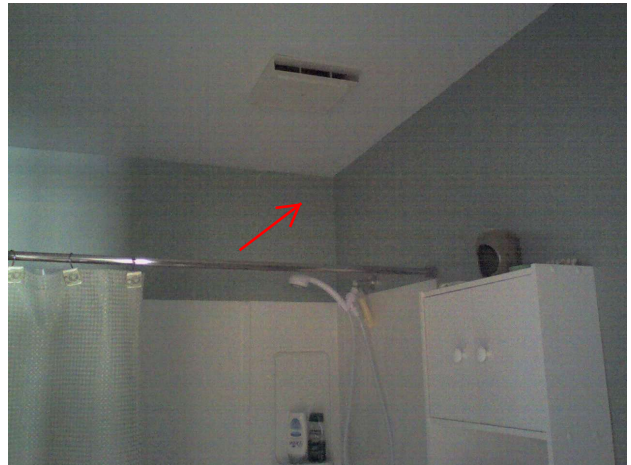
Description
moisture intrusion from the ceiling/attic

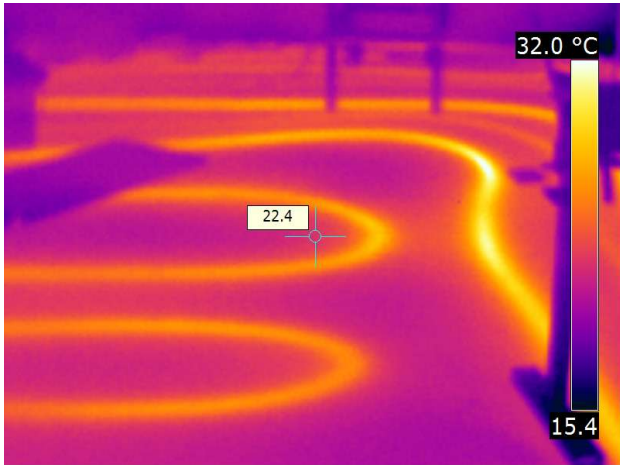
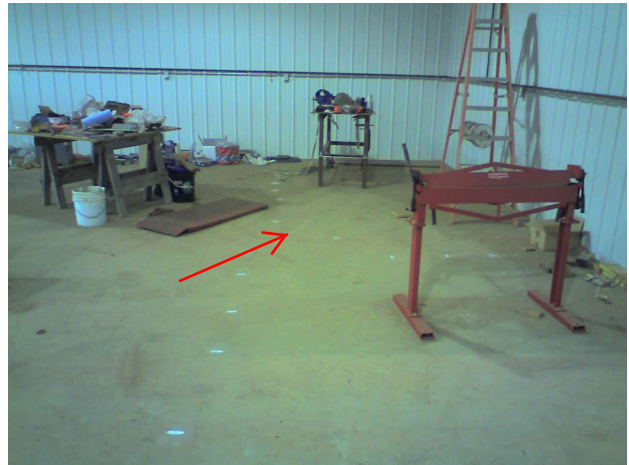
**Description**  
in floor heating lines were located so further renovation can take place

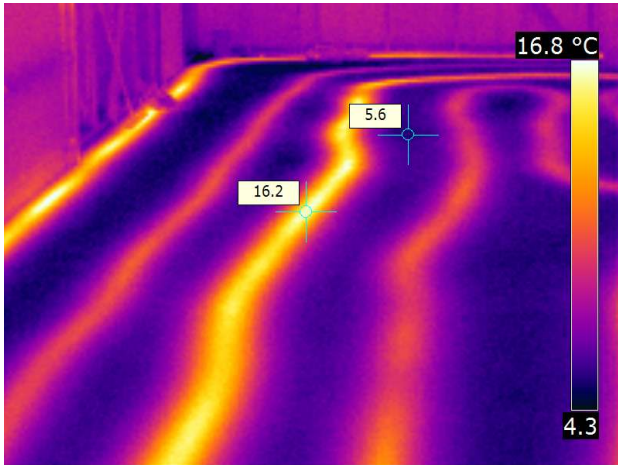
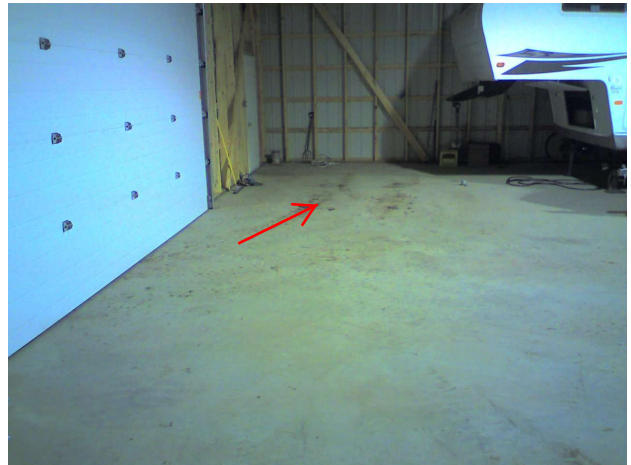
Description
hot water lines in the cement floor
