Inspection Report

Report Date 21/10/2009

Company Heat Seeker - Thermal Imaging
Address 119 Kutz Cres, Saskatoon, Sk S7N 4S5
Thermographer Clifford Gerow

Customer Paul Jones
Site Address 218 Fun Street Saskatoon, Sk
Contact Person Paul Jones

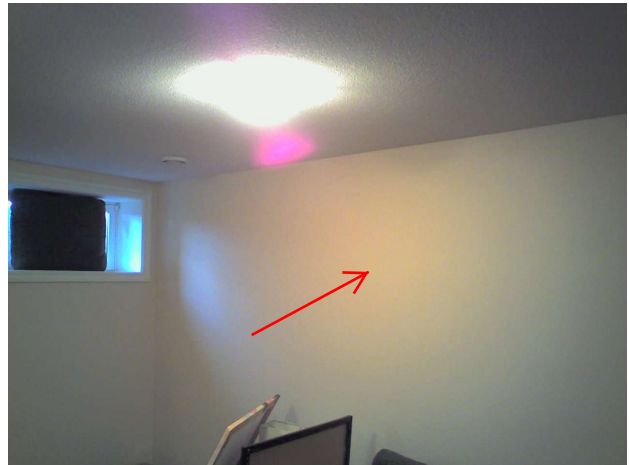
Description
missing insulation behind the finished wall in the basement

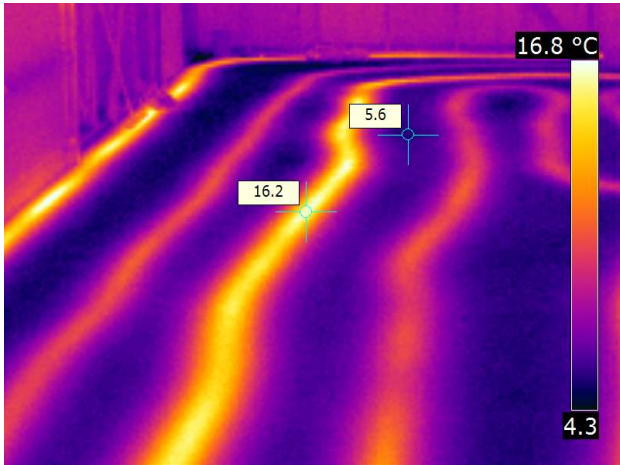
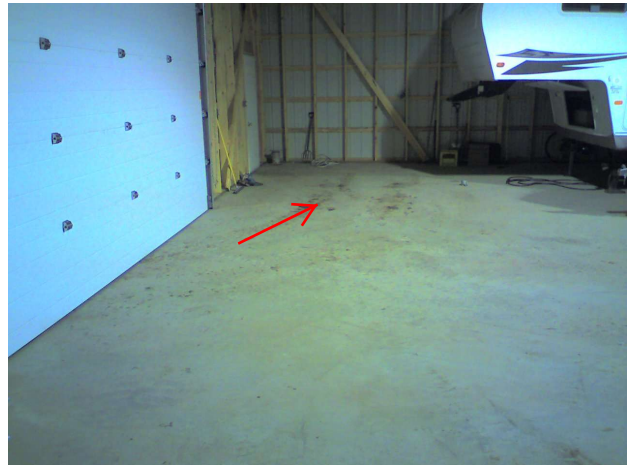
Description
hot water lines in the cement floor
